TECHNICAL REPORT  
NADC 82047-60

# ADVANCED FLIGHT CONTROL ACTUATION SYSTEM (AFCAS - E/P)

Fabrication and Design Verification Testing of a  
Dual Mode Electro/Pneumatic Actuator for the  
T-2C Aircraft

Bendix Corporation  
Flight Systems Division  
Teterboro, New Jersey

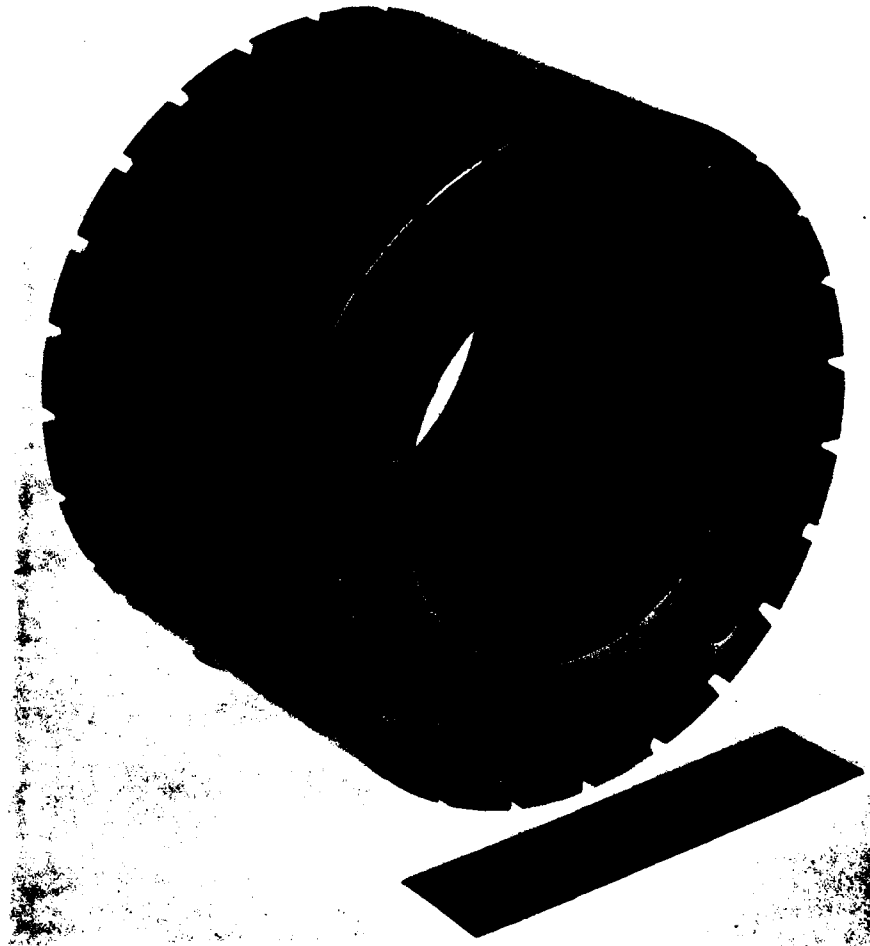
FIGURE 7

ROTOR
